LASER CLEANING ON BART'S TRANSBAY TUBE RETROFIT

BY ROBERT IKENBERRY, CALIFORNIA ENGINEERING CONTRACTORS;
WITH JIM HEALY, CALIFORNIA ENGINEERING CONTRACTORS;
ETHAN STANDEN, SHIMMICK CONSTRUCTION; AND
MARK STEWART, STEWART CONSULTING SOLUTIONS

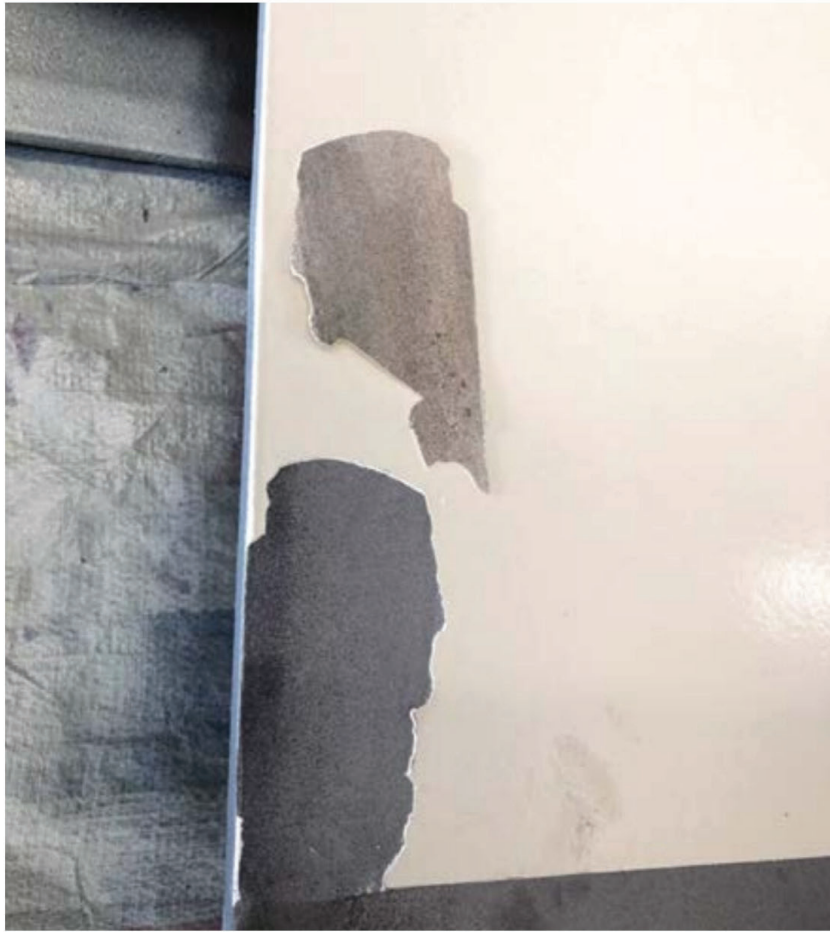
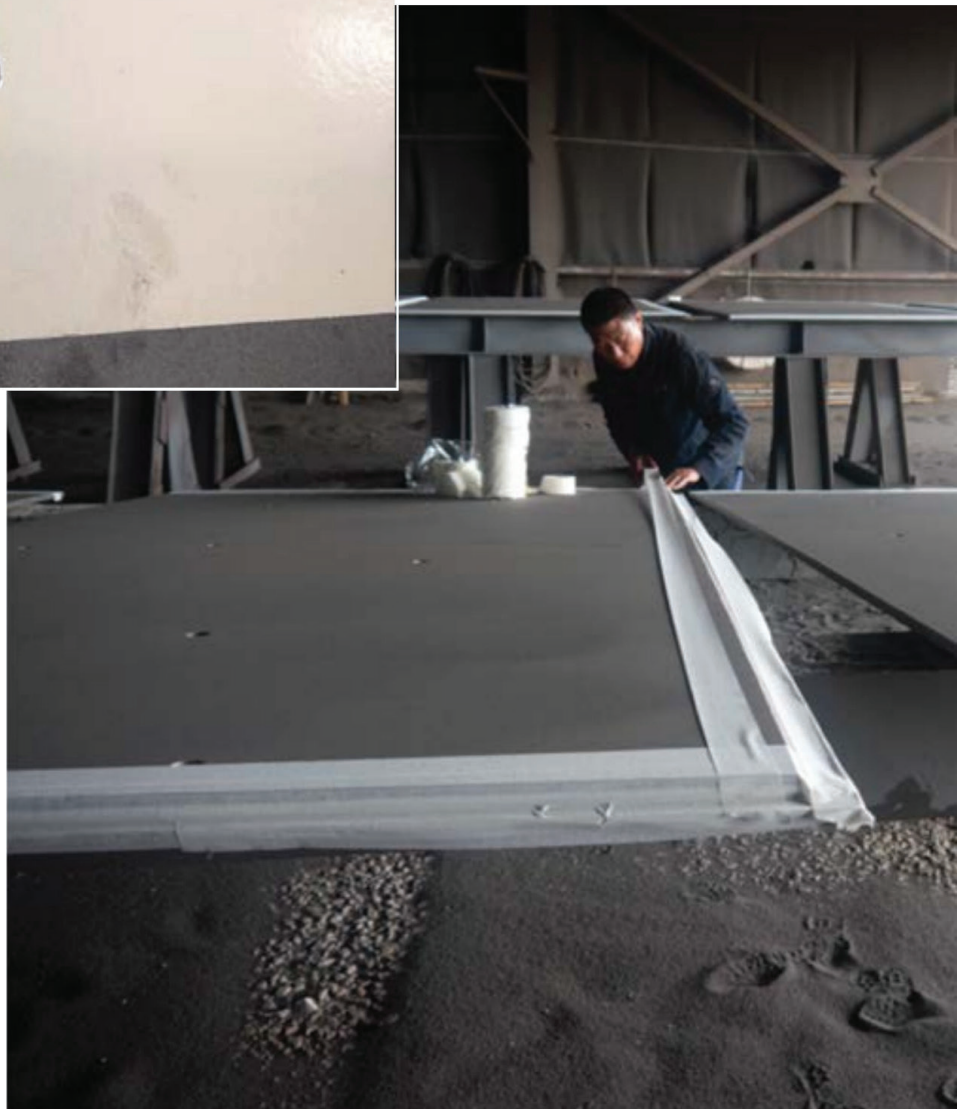
FIG. 3 (above): Plates with masking (note edge with no masking)

FIG. 4 (right): Lifted coating and large chip flipped over

contamination. Several inches of the coating on the edge of the plate is loose, but is tightly adhered on the rest of the plate (*Figs. 3 and 4*).

After much investigation and head-scratching, the layout foreman finally confessed that he had originally asked the masking crew to mask off the unbeveled edge of the plate, which they had done. Then he realized that only the three beveled edges needed masking, so they had removed the tape. This was done in the blast room. The final step was to blow down the plates before they were moved to the paint

room. Apparently, dust stuck to the small amount of adhesive which was left over and caused a total coating adhesion failure.

The fix was simple – the plate was re-blasted and re-coated – but it got me thinking that we had a potential big problem in the tube, when months or years later, after ocean shipment, handling, installation, welding, NDT and exposure to the operating trains, we were going to have to clean and paint all these weld lanes. No blasting would be allowed in the tube, and no solvents would be permitted.

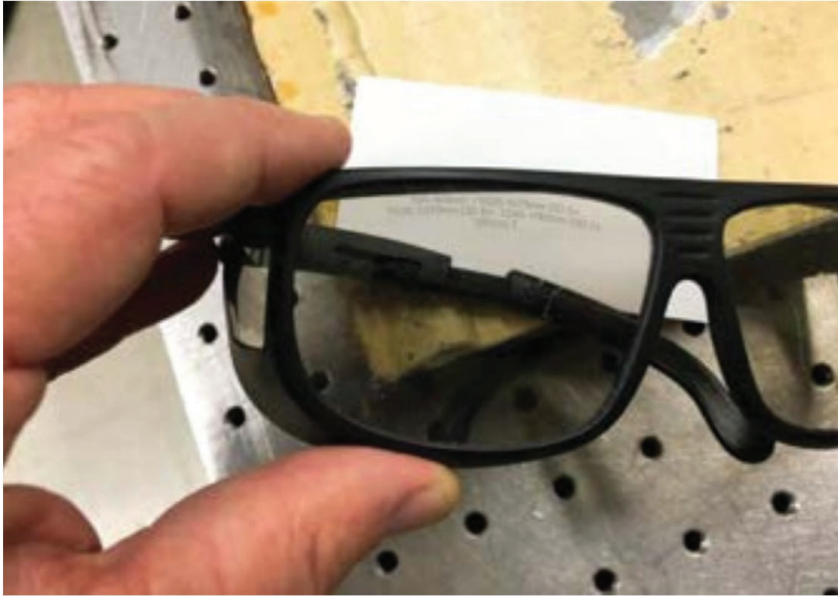
FIG. 7: Protective eyewear with OD of 7 for IR radiation at 1064nm

Another reference is that to safely be around the laser, you need to wear safety glasses that have an infrared (IR) radiation protection factor (Optical Density or OD) in the wavelength of the laser (1,064 nm) of 7+ or less than 1/10,000,000 transmission. These safety glasses block out 99.99999% of the laser light.

To put it another way, if you have ever cupped your hand over a powerful flashlight in a dark room, you can still see a dim red glow through your hand. If IR worked the same way as visible light (it probably doesn't), covering your eye with the palm of your hand likely only provides a visible light OD of about 4 to 6. So, the intensity of the laser light would still be at least ten times too bright to safely look at—through your hand! (*Fig. 7*)

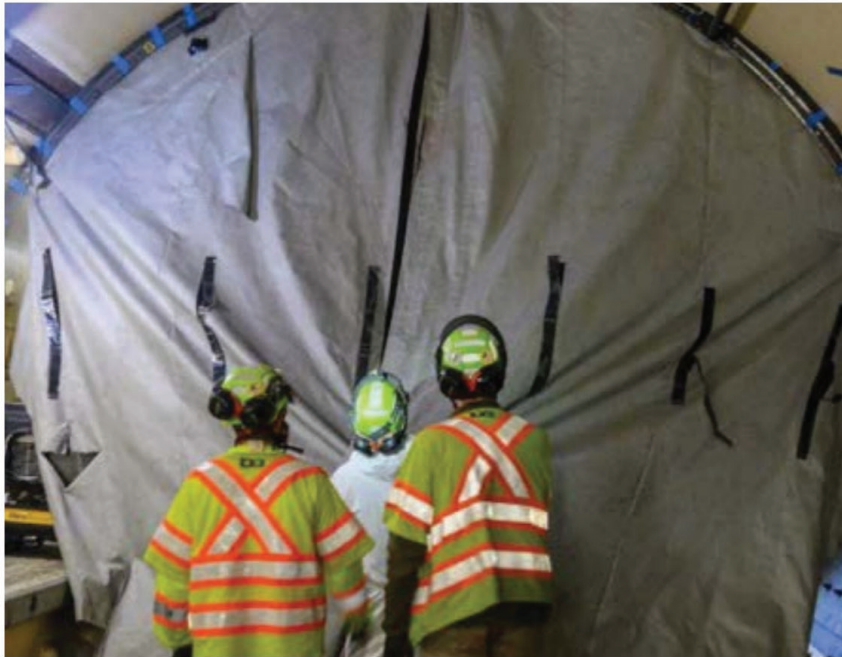
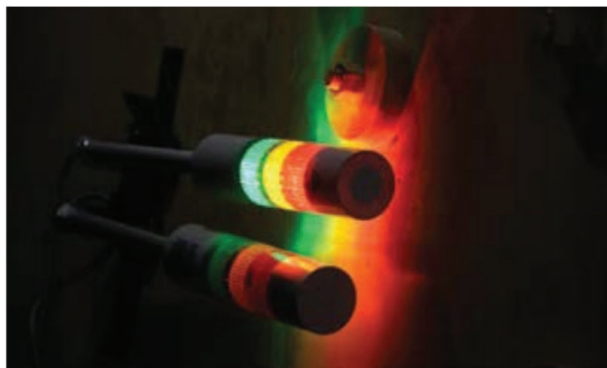
Top to bottom:
FIG. 8: Laser Drape
isolating the Laser
Controlled Area

FIG. 9: Laser unit, green
light = power on, no
high voltage

FIG. 10: Lasing—
all three lamps
illuminated

Adjacent to the interlock at the drape was a Visible Laser Radiation Emission Warning Device with three lamps. If all the lamps were dark, the laser was disconnected from power. If the green lamp was on, the laser had power but was not ready to fire. If the yellow lamp was on, the laser was powered up and ready to fire (high voltage on) but was not working at that time. If the red lamp was illuminated, the laser was operating. Before the yellow lamp was armed, all non-laser workers exited the laser work area and the entry to the enclosed area was secured. No one was permitted to open the drapes or otherwise defeat the interlock if the yellow or red lamps were on. Laser warning signs were posted at each entrance. The entire tube between the drapes became an Interlocked Removable Protective Housing, and a Laser Controlled Area as required for Class 4 lasers (*Figs. 8-10*).

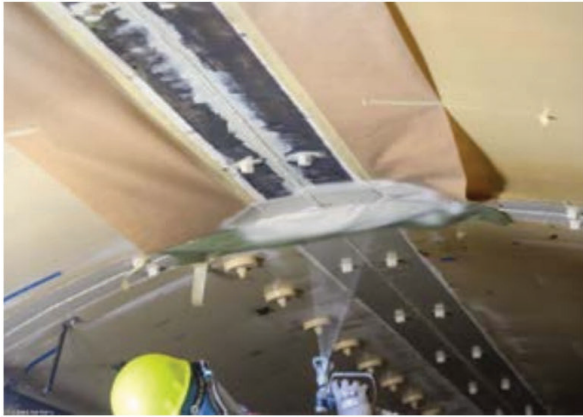
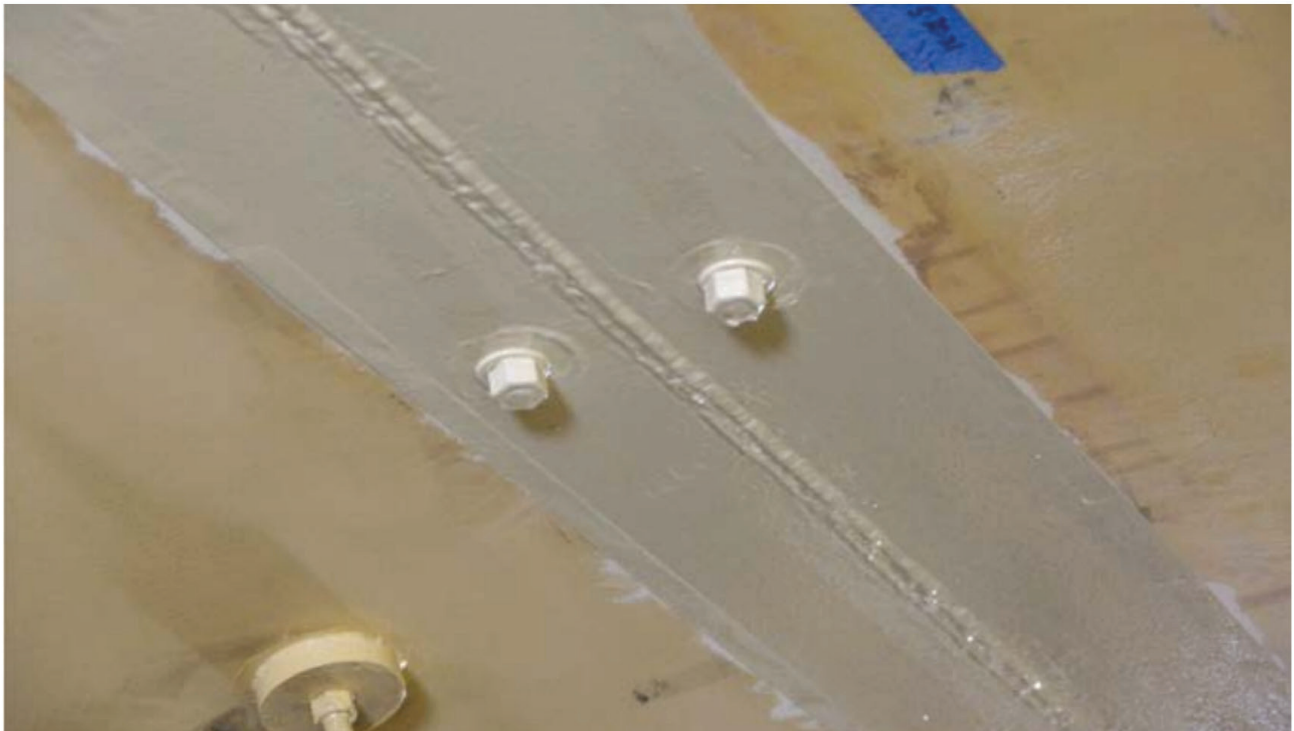
FIG. 12: Spray application

FIG. 13: Checking WFT

FIG. 14: Finished weld lane

laser cleaning system and a full-scale plural-component pump system, we were able to apply the coating at rates multiple times faster than the manual cleaning (such as bristle blasting to SSPC-SP 11) and cartridge spray production rates we had originally anticipated (*Figs. 12-14*).
